Mystery flats near the valve? Maybe not so mysterious!

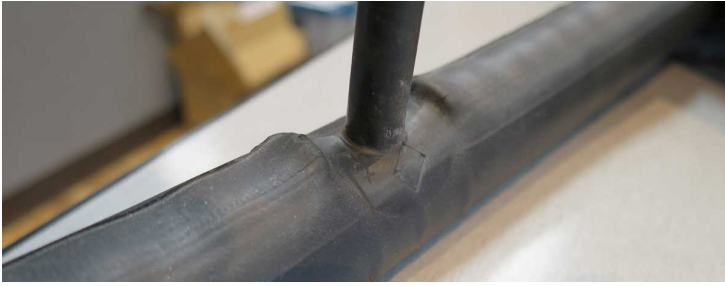
Those two bulging spots near the valve? They are **not** weak spots in the tube! Or at least they weren't weak/defective when installed. Read on.

This particular tube was leaking at one of those bulges. No surprise there; they look scary and the rubber has thinned out. But how? Nothing funny about the rim or tire.

Here's how it happened. During inflation, the person pumping up the tube is pushing the tube's valve up into the tire, creating a cavity underneath. As the pressure increases, the tube fills in underneath, bulging downward into that cavity. That's how you get those funny spots either side of the valve. Over time, sometimes not too much time, that thinned-out tube fails. In the smaller photo, you can see what look like small cuts; those are the areas the tube has split and now leaks.

What to do? Make sure you're not pushing the valve up into the tire as you pump! Especially if you're inflating a tube that already has a fair amount of air in it, since pushing it upward under those conditions pretty much guarantees the tube is going to try and bulge in to fill the empty space. --Mike--

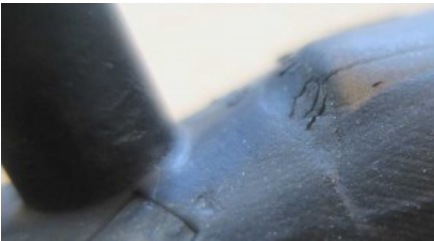
Closeup, showing the lines to the right of the valve, where the tube has developed leaks from being stretched too thin.
